Cycle Plant with Air-Cooled Condenser

CASE STUDY - POWER

Filming Corrosion Inhibitor

Reduces Corrosion in Combined

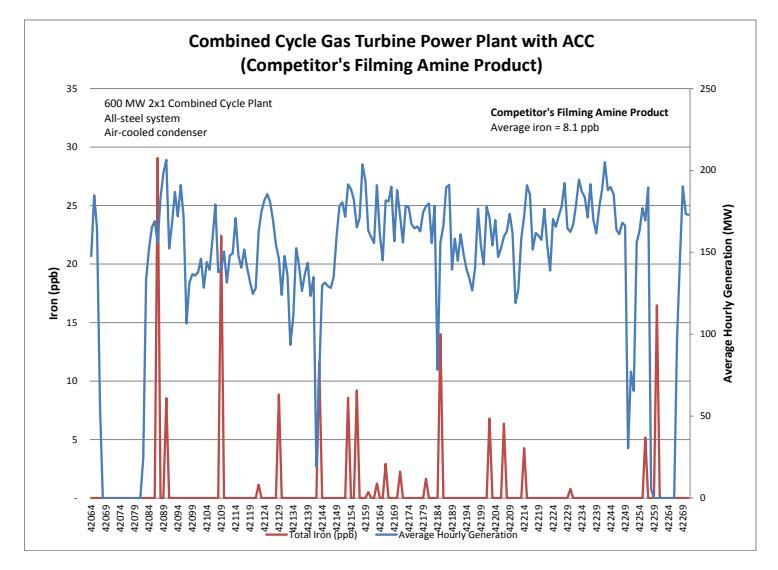
Figure 1: Operational graph showing corrosion product generation under competitors filming amine product.

In addition to the filter analysis, MW generation data was collected from the plant historian. Coupling this data with the corrosion product data and annotated with operational details provided context and a clear view of the impact of the corrosion inhibitor on the plant's operation. The results are shown in Figures 1 and 2.

The plant ran in an almost base-loaded condition from the start of the incumbent treatment in March through the end of September 2015. Then an operational problem put the plant into an unscheduled outage, followed by limited production in a 1x1 configuration. During this time, the new treatment was fed intermittently. In mid-January 2016, the plant returned to a more normal production schedule. After collection and review of a statistically valid dataset, the head-to-head comparison of the relative performance of the two treatments was complete and the data was clear. The new treatment outperformed the incumbent inhibitor, reducing corrosion product generation by 40% at the same dosage rate.

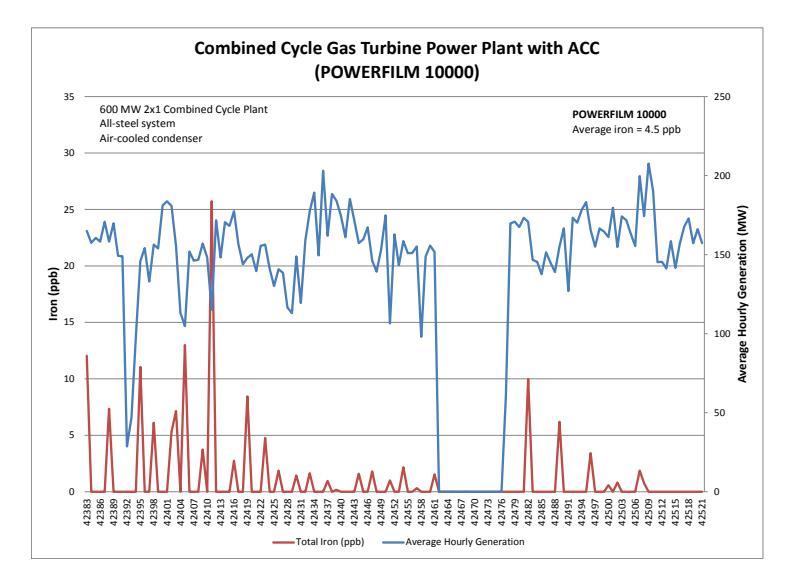
Figure 2: Operational graph showing corrosion product reduction using Nalco Water POWERFILM™ 10000
